FATIGUE TESTING OF VAMPIRE WINGS. (U)

STRUCTURES REPORT 378

FATIGUE TESTING OF VAMPIRE WINGS

R. A. BRUTON and C. A. PATCHING

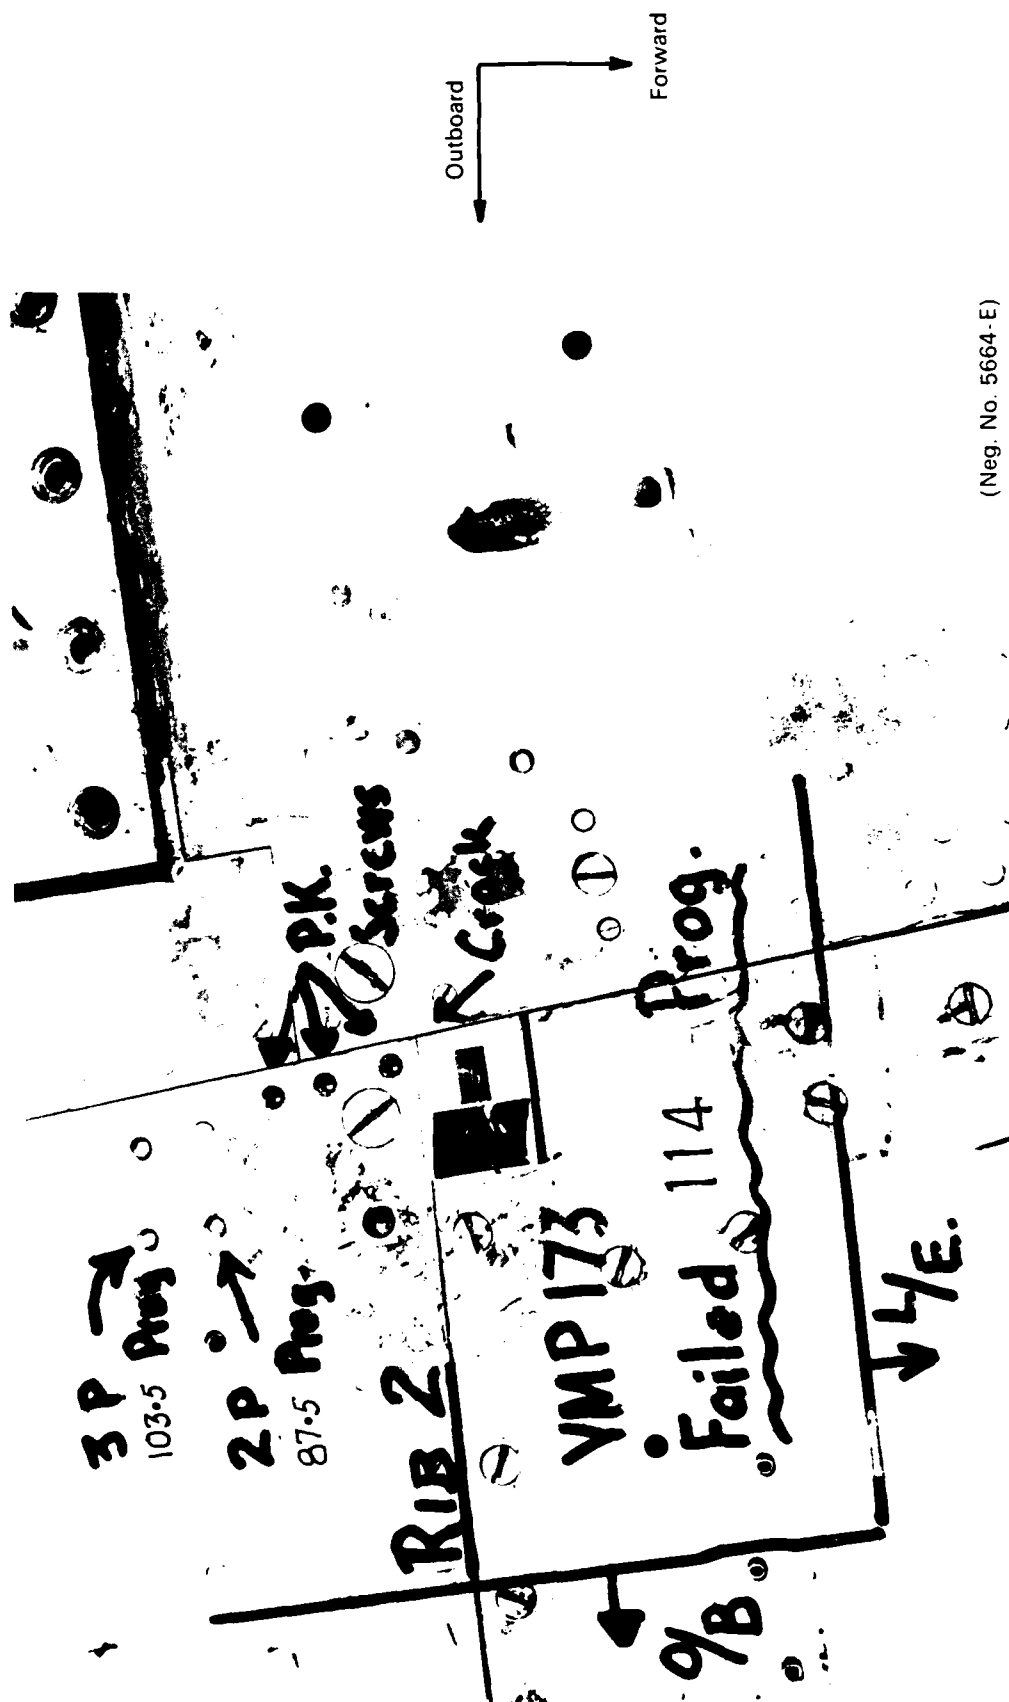
(Neg. No. 5664-E)

FIG. 13: LOWER SURFACE AT RIB 2 SHOWING POSITION OF P.K. SCREWS AND STRAIN GAUGE ON SPAR BOOM

An electric resistance strain gauge was mounted on the spar boom at Rib 2 (see Fig. 12) close to the expected path of the fatigue crack. However, the measured strain from this gauge remained virtually unchanged until collapse was imminent. This could be attributed to a number of factors including the following:
